Little Brazos River Tributaries Bacteria Assessment

Jay Bragg
Regional Environmental Planner
Brazos River Authority

*Project funded by the Texas State Soil and Water Conservation Board

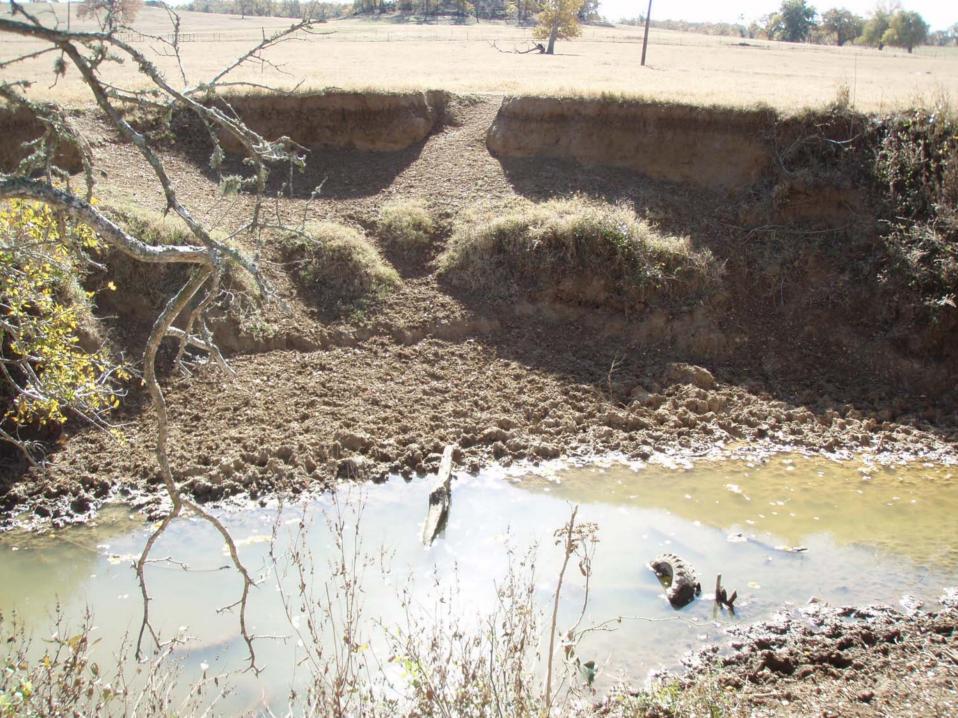
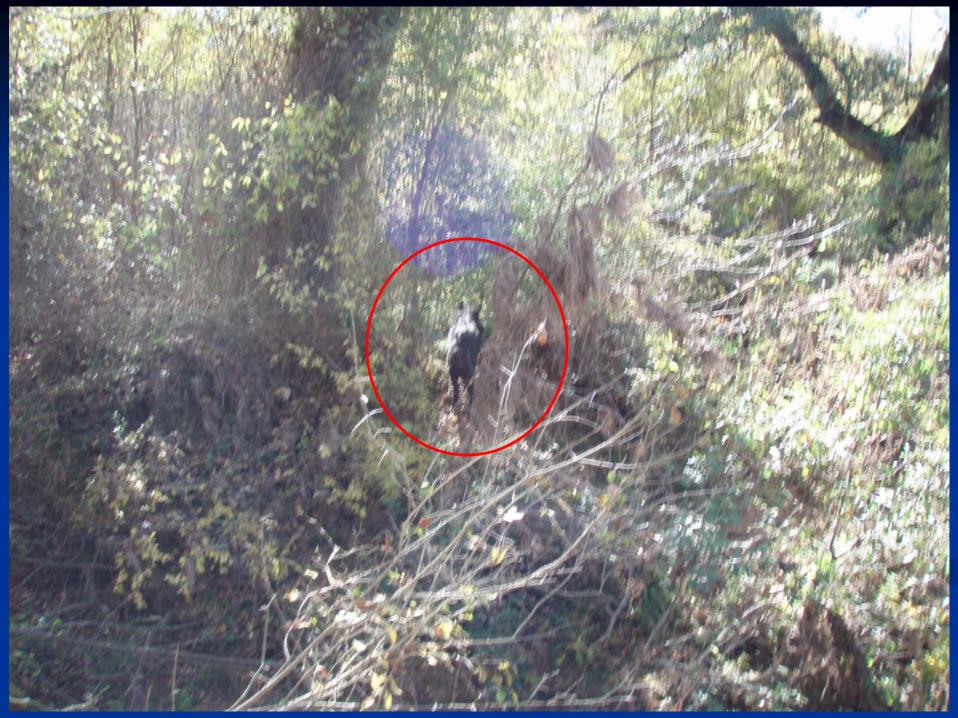
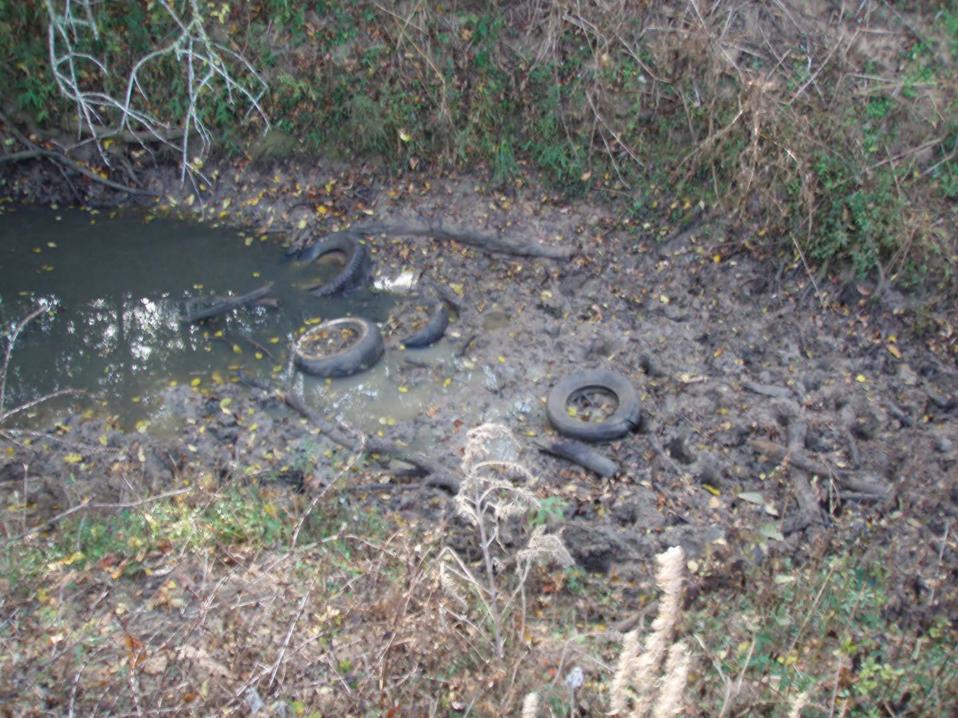
Field Notes

033	20-Nov-08	30.75486	-96.49472	1791	hog traces
034	20-Nov-08	30.75637	-96.49259	1792	water gap holding debris
035	20-Nov-08	30.7568	-96.49237	1793	cattle tracks at stream crossing
037	20-Nov-08	30.76181	-96.48866	1794	house >1000m away
038	20-Nov-08	30.76318	-96.48762	1795	cattle crossing with feces
039	20-Nov-08	30.76307	-96.48642	1796	armadillo
040	20-Nov-08	30.76379	-96.48624	1797/1798	concrete, bricks, tires
031	20-Nov-08	30.76514	-96.48514	1799	metal tubing and tires
031	20-Nov-08	30.76514	-96.48514	1800	lots of cow tracks and feces
041	20-Nov-08	30.76616	-96.48307	1801	cattle crossing under HW6 bridge massive erosion
042	20-Nov-08	30.76649	-96.48032	1802	cattle crossing
042	20-Nov-08	30.76649	-96.48032	1802	large runoff from railroad
043	20-Nov-08	30.76681	-96.47983	1803/1804	deer
043	20-Nov-08	30.76681	-96.47983	1805	creek draining from pasture
044	20-Nov-08	30.7676	-96.47978	1806	confluence from pasture with flow

044	20-Nov-08	30.7676	-96.47978	1806	major cattle crossing
045	20-Nov-08	30.76786	-96.479	1807	foul smell and lots of tracks
046	20-Nov-08	30.76776	-96.47742	1808	feeding bins about 200m away on left
048	24-Nov-08	30.74307	-96.49728	1814/1815/1816	hay, lots of tires, printer, plumbing, wood, tons of trash

- Lots of cattle crossings and watering holes
- Evidence of feral hogs, deer, raccoons, armadillos, birds and other wildlife
- Lots of older tires in the creek bed
- Some Illegal dumping of household and construction wastes
